# Drive Unit

## Product Information XBEB A85

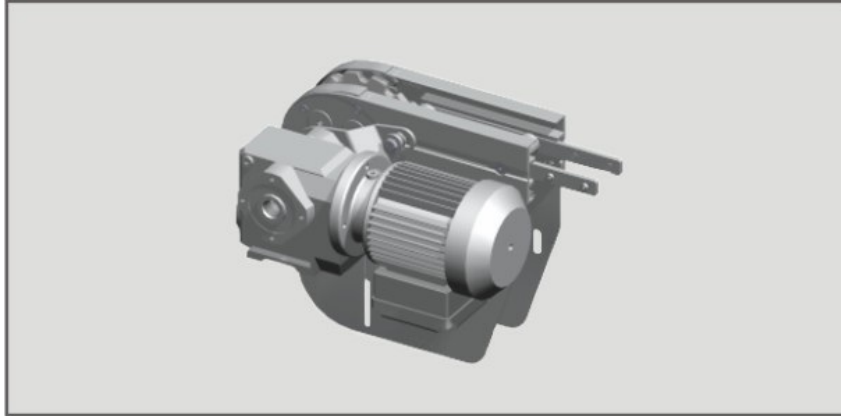
<b>Product Number</b>	XBEB A85	<b>Product Group / Product Type</b>	X85 / CD01
<b>Name</b>	End drive unit		
<b>Description</b>	HPV-L-G-V6-29-WA30-MM07-50 Hz/380-500-C-P< ( <a href="http://repl.flexlink.com/os/loadcart.htm?cartid=197604">http://repl.flexlink.com/os/loadcart.htm?cartid=197604</a> )</td>		
<b>Unit</b>	PCE	<b>Class</b>	C
<b>Weight</b>	15.0 kg	<b>Country of origin</b>	Poland

- **Actual max speed at 50 Hz** 29 m/min
- **Actual min speed at 10 Hz** 5.6 m/min
- **Actual chain pull** 1205 N
- **Motor power** 0.75 kW
- **Motor Ampere** 1.9 A
- **Brake** No
- **Energy efficiency class** IE3
- **Motor designation** DRN80M4
- **Motor family** Movimot

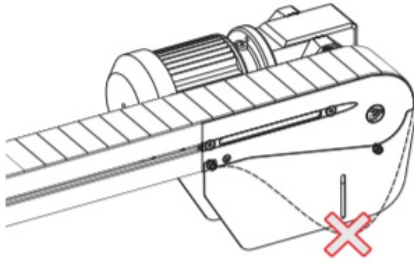
- **Check the protective cover on the cleated chain conveyor return chain.**
- **Drive units type H, have a slack protection for the conveyor chain. Check that the slack protection plates are in place,**

and that the chain does not slacken enough to hang below the plates.

- Check the protective cover for the conveyor chain on intermediate drive units.
- There may be other types of guarding which are specific to your installation, and these must also be checked. See the system documentation.
